Advisory Number: SPA-24-03-01

Dealer Advisory

ROPS Installation

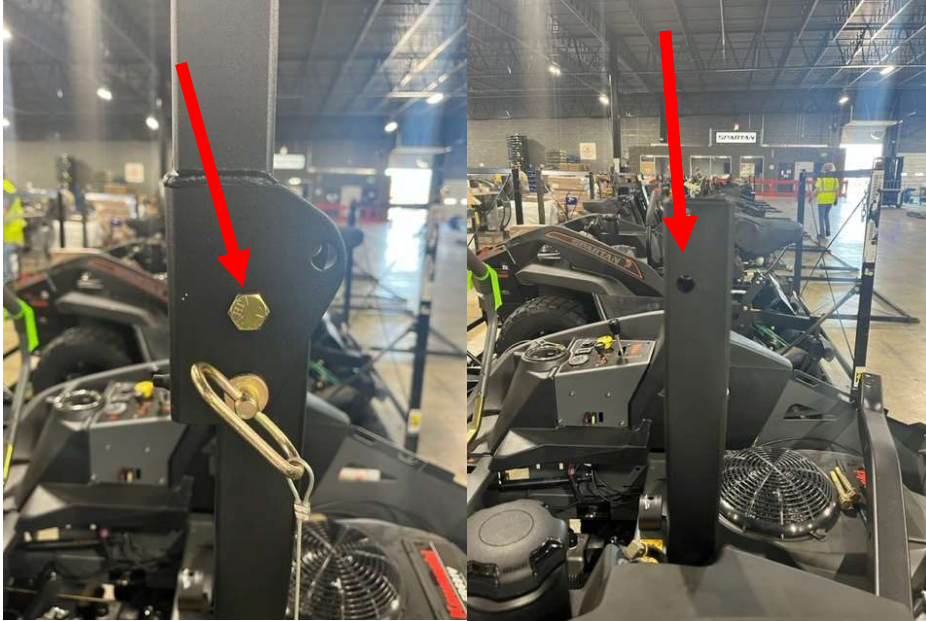
Figure 1

Below are pictures of ROPS that are installed incorrectly. The upper ROPS mounting holes are positioned towards the front of the mower (incorrectly). When the ROPS are folded down, the pin holes will not line up. (Figure 3)

Install the lowers ROPS brackets with the upper ROPS mounting holes positioned towards the rear of the mower, so that the folded position has proper pin hole alignment.
